May 28, 2020

VIDEOJET SAFETY ALERT & ADDITIONAL SOFTWARE IMPROVEMENTS

**Videojet CIJ Models 1210, 1220, 1510, 1520, 1530, 1550, 1560, 1610, 1620, 1630, 1650, 1660, 1610 Dual Head, 1620 HR, 1620 UHS, 1650 HR, 1650 UHS**

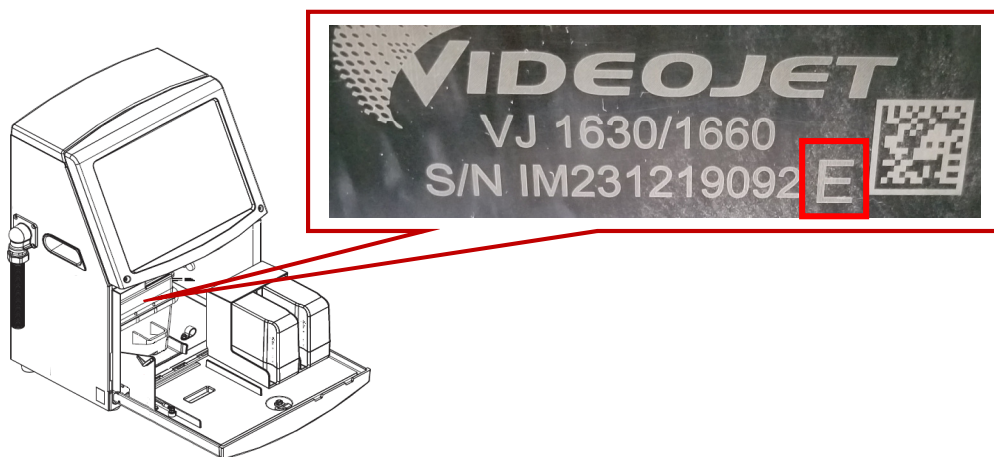
To determine if your currently installed or any spare Ink Module is subject to this notice, inspect the Ink Module serial number located on the face of the Ink Module above the handle inside the printer cabinet of each printer. When inspecting an installed Ink Module, follow all safety guidelines listed in Chapter 2 – Safety of the Videojet Service Manual for your equipment model. If the Ink Module is revision D or higher, no further action is required.

The Ink Module revision level can be found laser etched on the face of the Ink Module above the handle as shown here:
